## Site Observation Report – 16477 21 Ave

| <b>Title:</b> | Site Observation Report |
| <b>Date:</b> | August 17, 2026 |
| <b>Project Address:</b> | 16477 21 Ave, Surrey V3Z 0V7 |

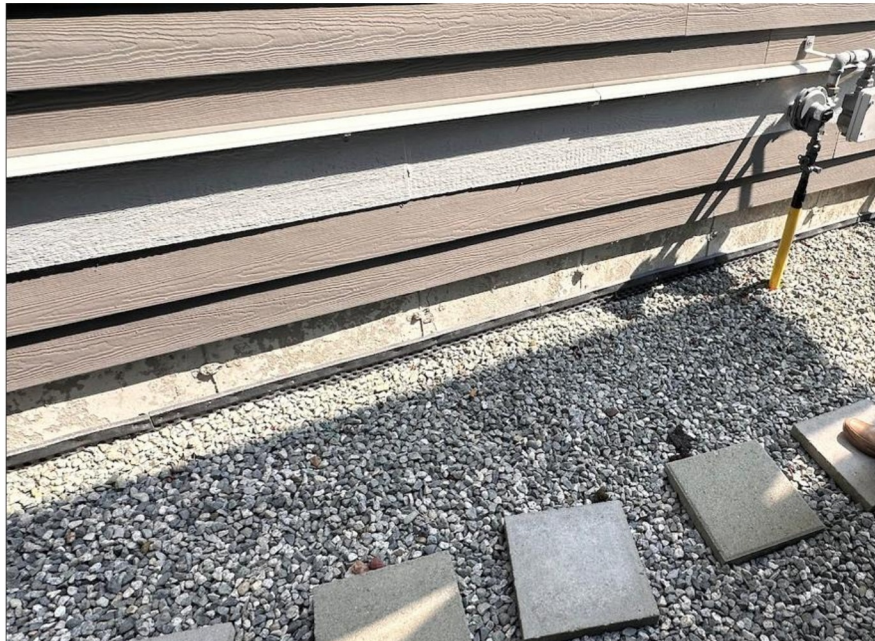
- The foundation crack was observed to be relatively small, measuring roughly 1/16" in width at the time of the site visit.
- The crack appeared localized, with no associated displacement or separation observed on the concrete adjacent to the crack.
- No apparent pattern of additional cracking was observed in the surrounding accessible areas that would indicate ongoing movement of the foundation or building.
- The residence appeared to be in generally satisfactory observable condition at the time of the site visit.
- No other cracking was observed on the accessible interior or exterior walls, flooring, ceiling, or finishes.
- No obvious signs of differential settlement or noticeable separation of building components were observed.
- It was noted by the homeowner that the crack has been present for at least ~5 years.

The observed crack in the exterior concrete foundation was approximately 1/16" wide. Based on its relatively small size, localized nature, and the absence of other observable indicators of movement or settlement, the crack was not observed to represent a significant structural concern at the time of the site visit. Figure 2 and 3 below shows the crack in the exterior foundation.

*Figure 2: Crack in the concrete foundation*

The crack may have been introduced during the original construction of the foundation, or may otherwise be attributed to normal concrete shrinkage, curing, or other construction-related effects. However, the precise cause of the crack may be confirmed with more invasive investigation.

A suitable repair would generally involve sealing the crack to prevent moisture or water from entering through the foundation. The crack may be sealed using an appropriate exterior-grade concrete crack sealant or flexible polyurethane-based crack injection/sealant system suitable for concrete foundation applications. The repair should be installed in accordance with the product manufacturer's recommendations. In addition, the repaired area should be monitored following the completion of the repair for evidence of renewed cracking, widening, or water infiltration.

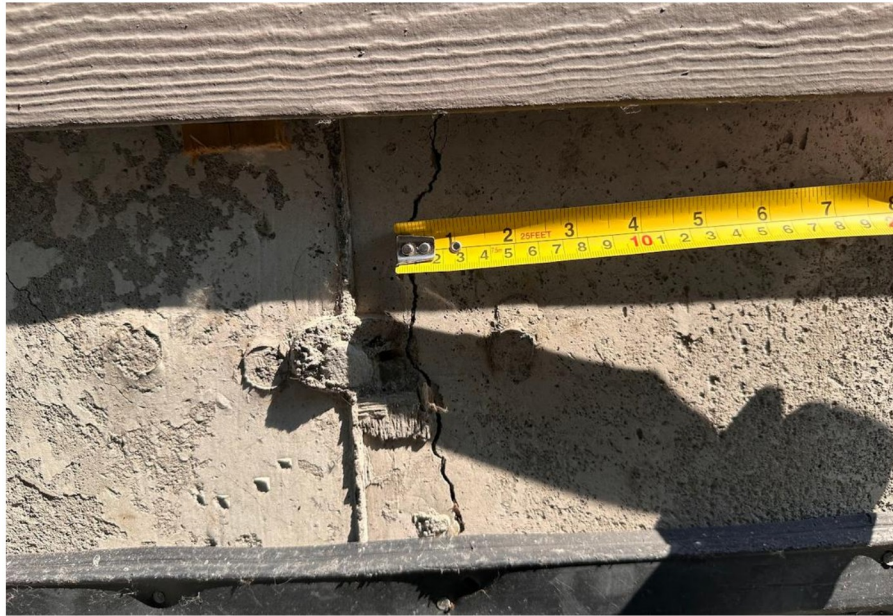
*Figure 3: Close up of crack in the concrete foundation*
