## Site Observation Report – Concrete Foundation Crack Repair

| <b>Title:</b> | Concrete Foundation Crack Repair |
| <b>From:</b> | Cornox Tang, Contech Engineering Inc. |
| <b>Project Address:</b> | 16477 21 Ave, Surrey V3Z 0V7 |

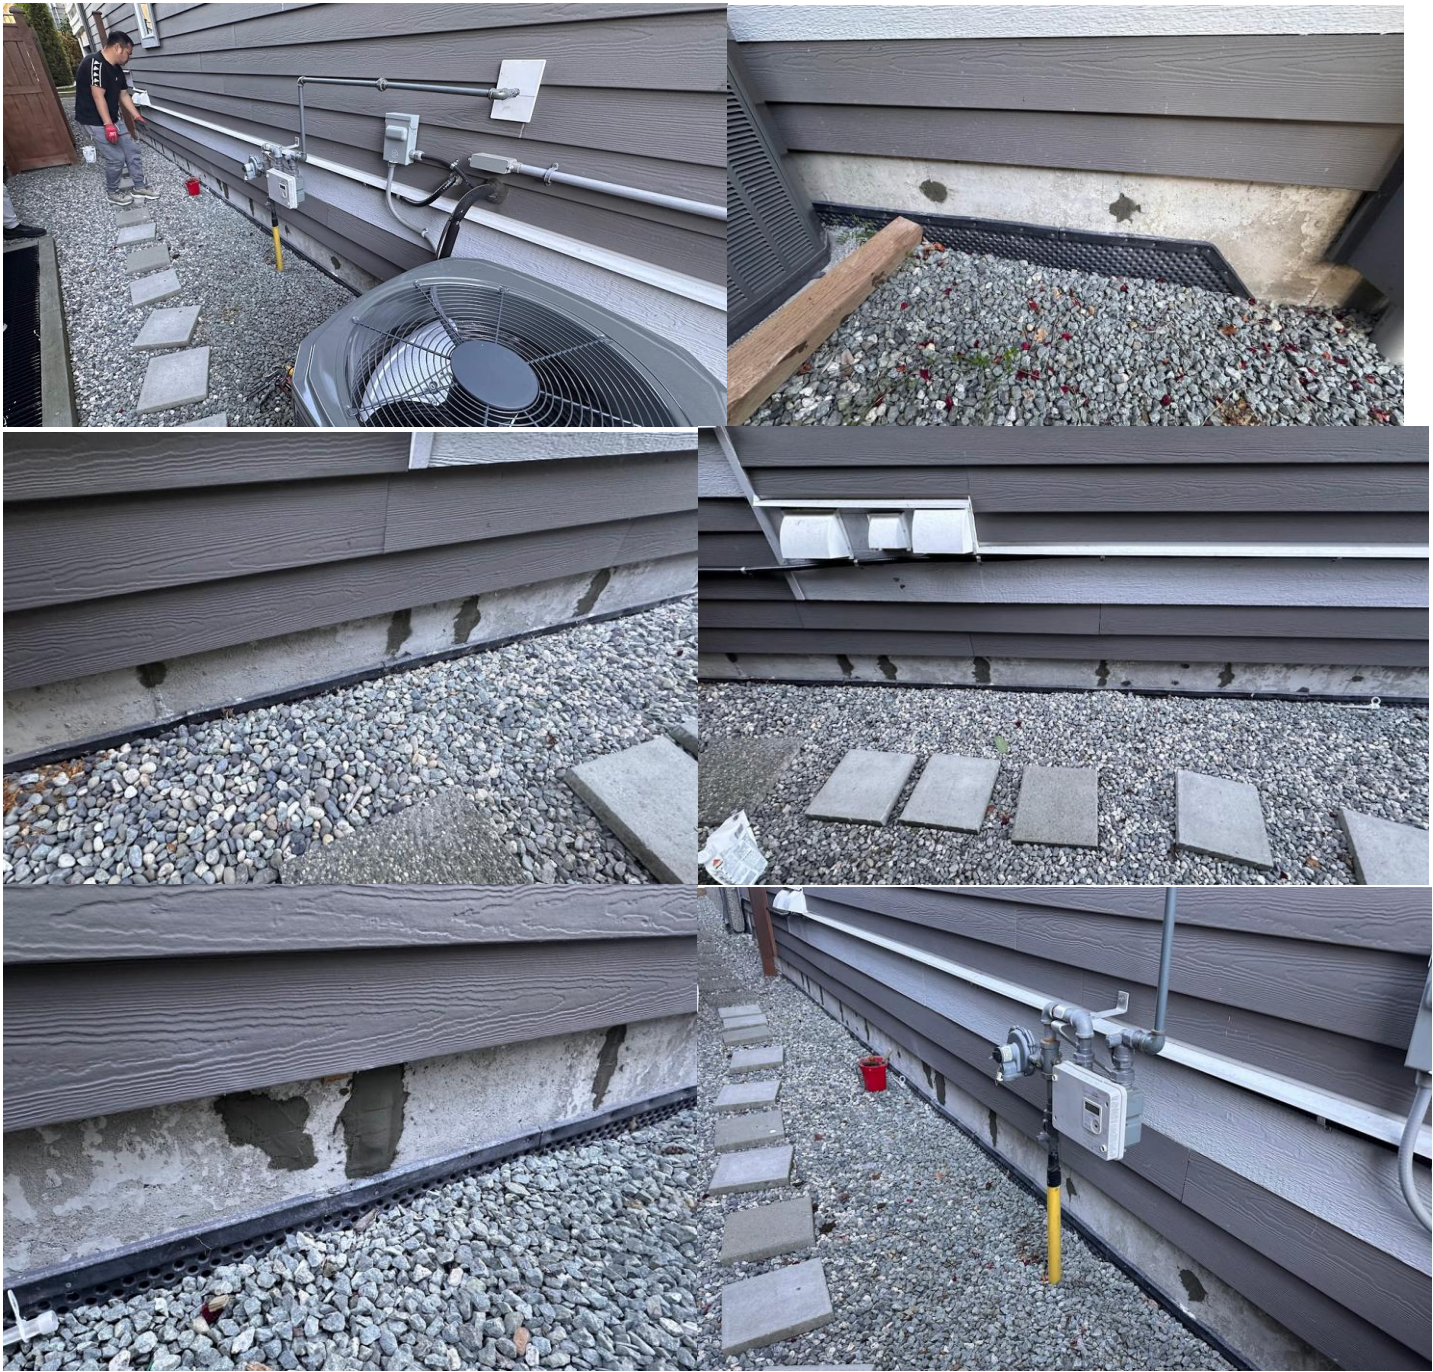
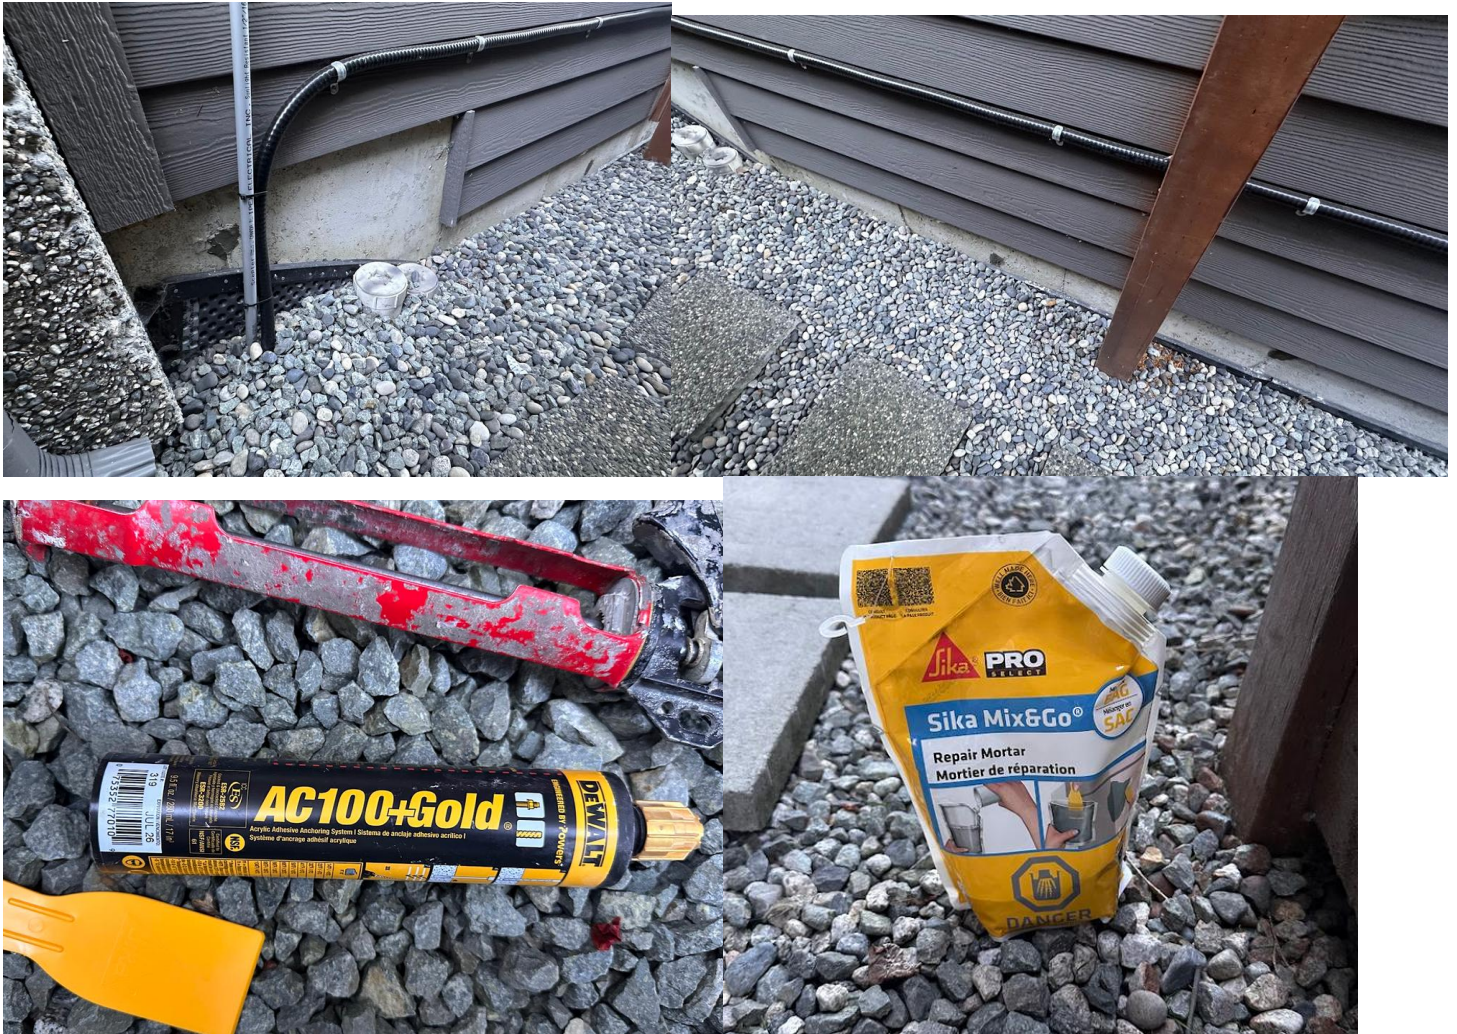
APPENDIX A: PHASE 2 PICTURES

The application of the repair material was visually reviewed during the work. The repaired areas were observed to have been filled with the repair material, with the material extending through the prepared crack areas.

adequately filled, with no obvious large voids or areas of missing repair material observed during the visual review. The repaired areas were left to cure prior to being finished during Phase 3.

Following preparation of the affected areas, Sika Mix&Go Repair Mortar was applied to the identified exterior foundation cracks.

The repair material was injected/filled into the prepared crack areas to fill the visible voids and provide a continuous repair across the affected portions of the concrete foundation.

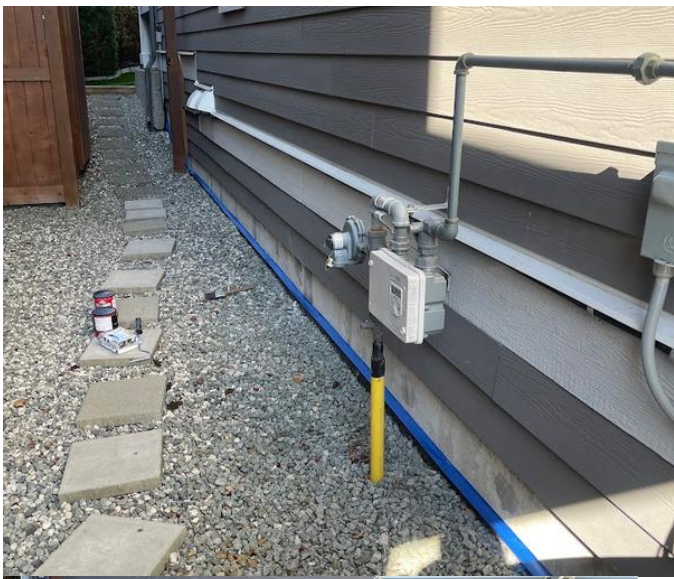
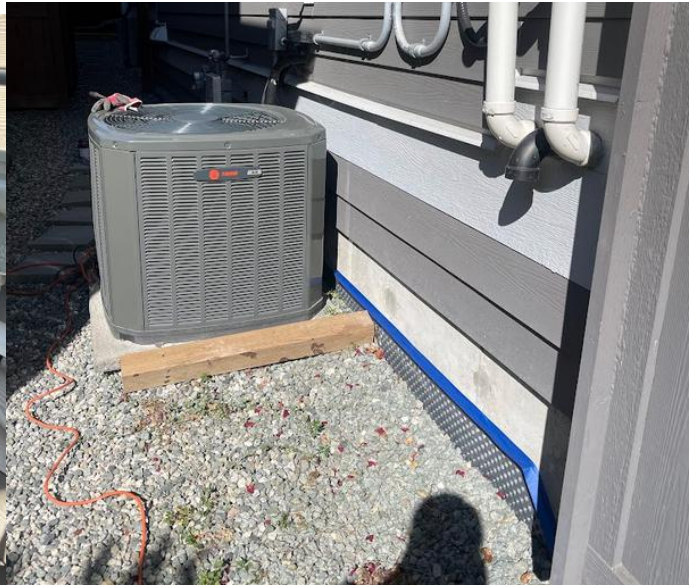
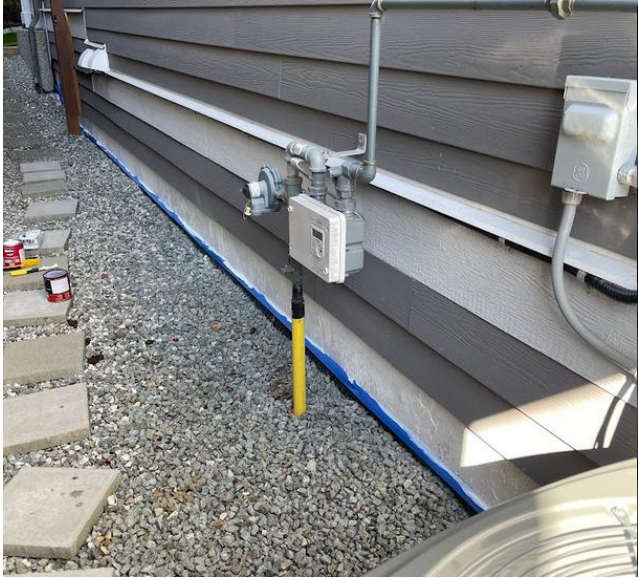
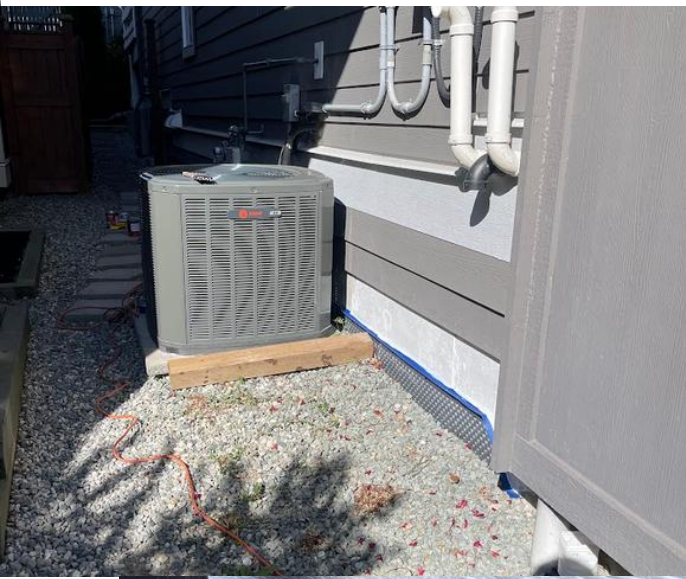
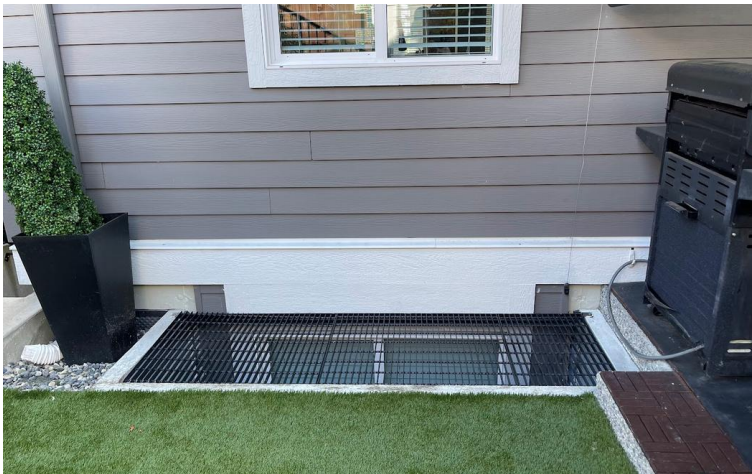
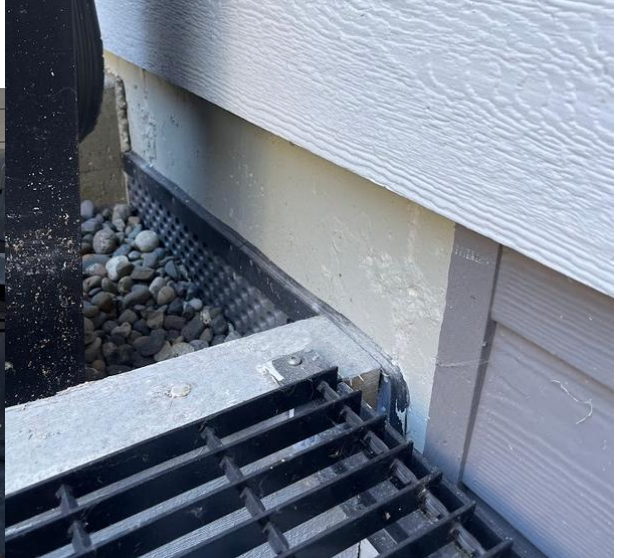
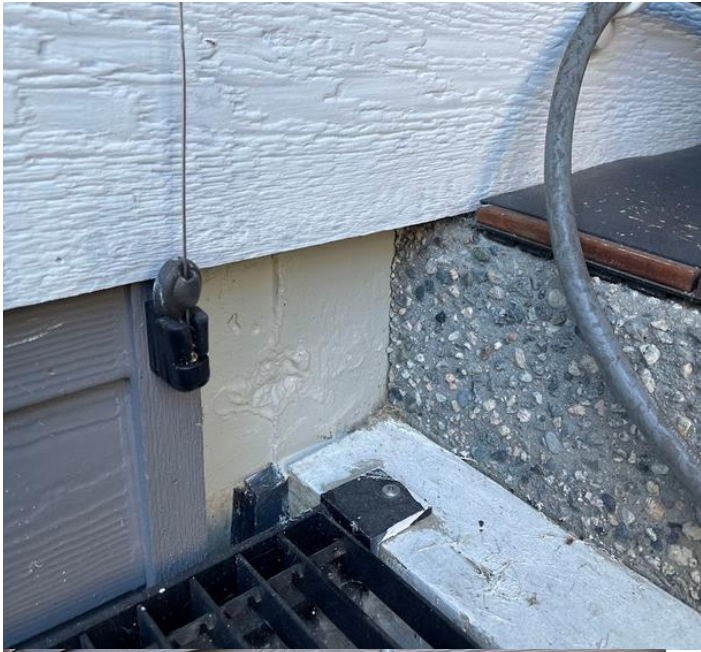
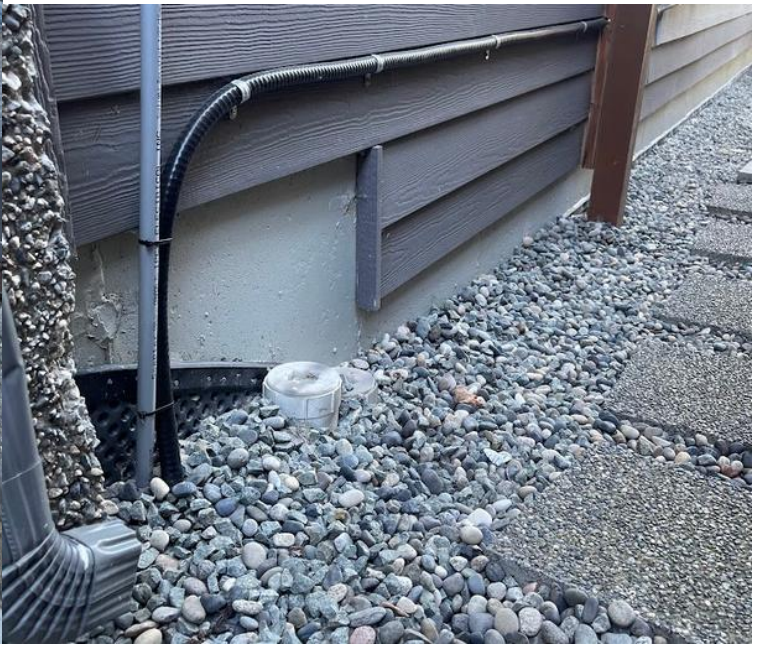
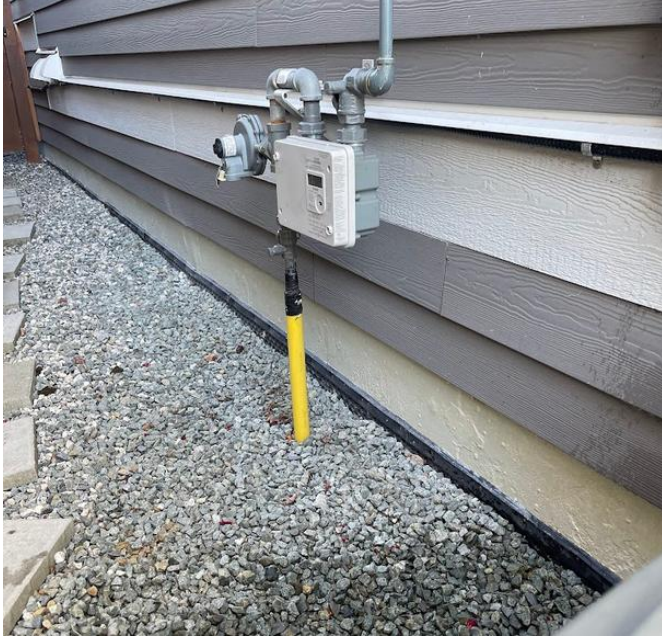
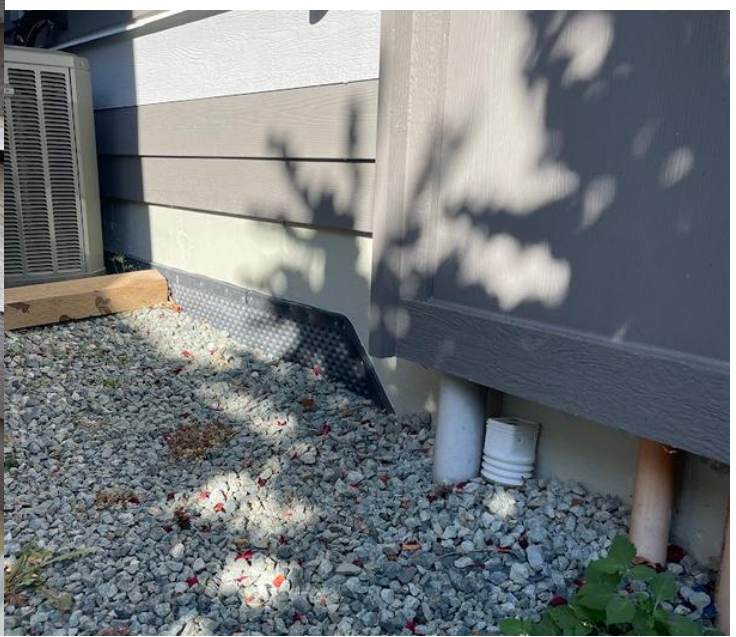
APPENDIX B: PHASE 3 PICTURES

Following completion of the sanding and painting, the repaired areas appeared generally continuous with the surrounding foundation surface. No obvious gaps, significant surface voids, separation of the repair material, or other apparent deficiencies were observed during the final visual review.

The repaired portions of the concrete foundation were sanded down to provide a relatively flat and smooth surface. This removed excess repair material and reduced surface irregularities resulting from the crack-filling process. Following sanding, the repaired areas were painted over to provide a finished surface and to improve consistency with the surrounding concrete foundation.
